DEPARTMENT OF NATURAL RESOURCES
DIVISION OF OIL, GAS AND MINING

RE: Site Visit, Cameron #1 Project, Native Asphalt Company, S/047/036,
Uintah County, Utah

Date of Inspection: October 10, 1990

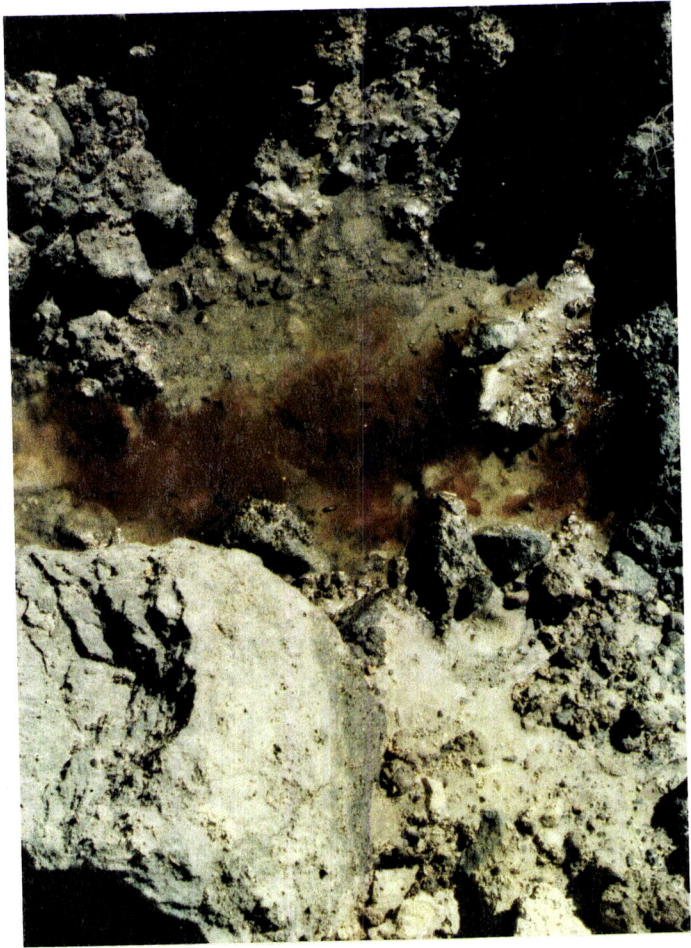
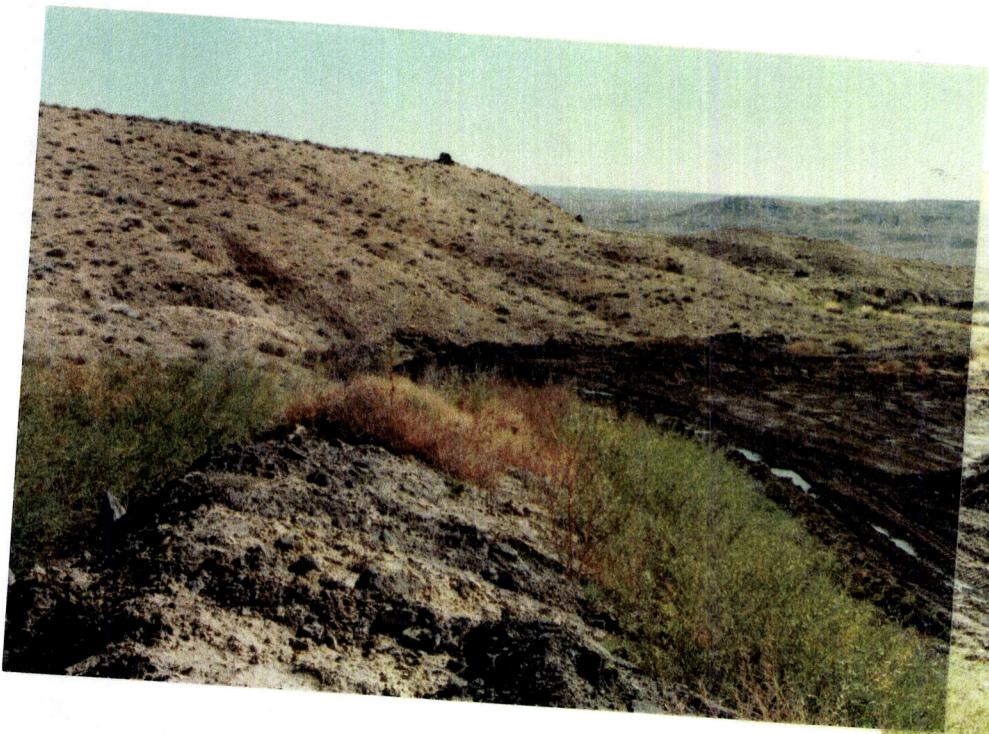
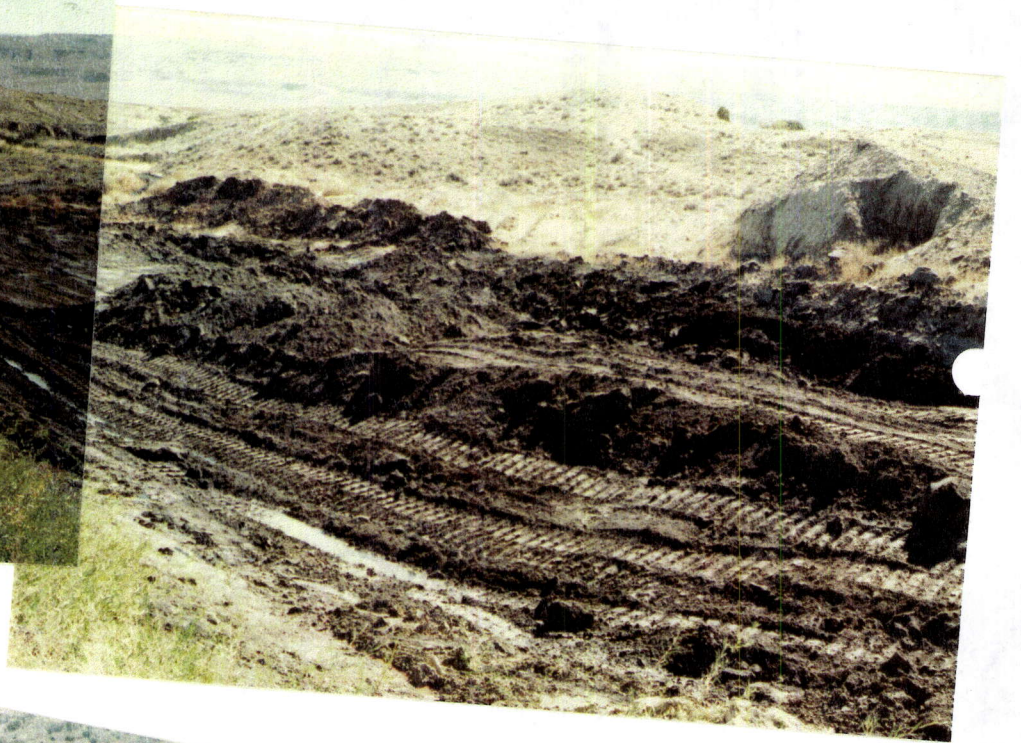
NATIVE ASPHALT CO. S/047/036
10-10-90

The operator's pit has been a focus of concern. It filled up with water this summer and was discharging water of degraded quality. The pit water was absorbing oils from the residual tar sands. The pit has since been drained and was empty during this last inspection.

DETAIL OF CURRENT ASPHALT PIT

- NOTE SEEPAGE DIVERTED TO LEFT

& PIT DRAINAGE DIVERTED TO THE RIGHT
